TECHNICAL INSTRUCTIONS

SAFETY RECALL E04

FRONT PASSENGER AIRBAG INFLATOR MODULE

CERTAIN 2003 – CERTAIN 2005 MODEL YEAR COROLLA CERTAIN 2003 – CERTAIN 2005 MODEL YEAR MATRIX

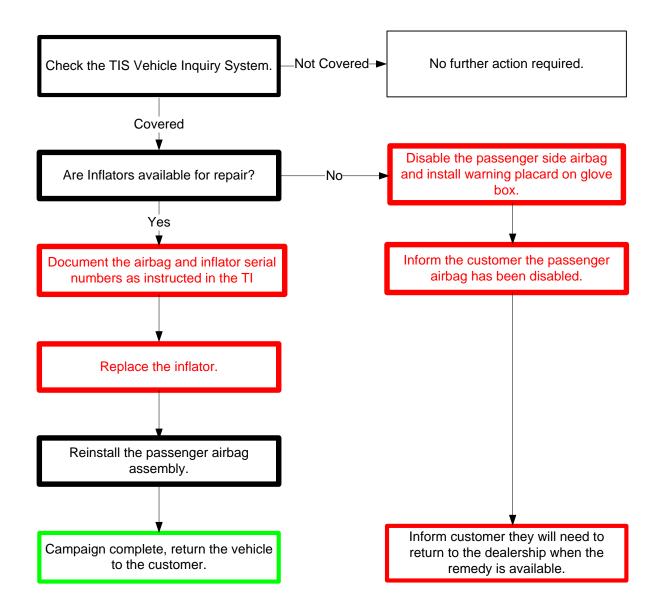
I. OPERATION FLOW CHART

The flow chart is for reference only. *DO NOT* use it in place of the full technical instructions. Follow *ALL* steps as outlined in the full technical instructions to confirm the campaign is completed correctly.

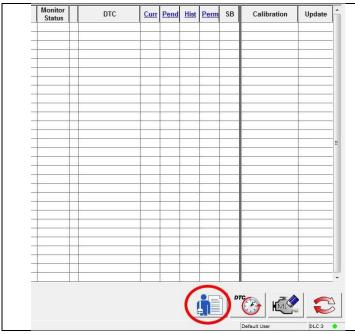
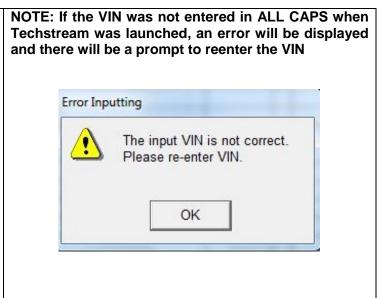
a) After the health check has completed, run a diagnostic report by clicking on the link on the health check screen.

b) Enter the vehicle mileage and repair order information, then click the 'report' button.

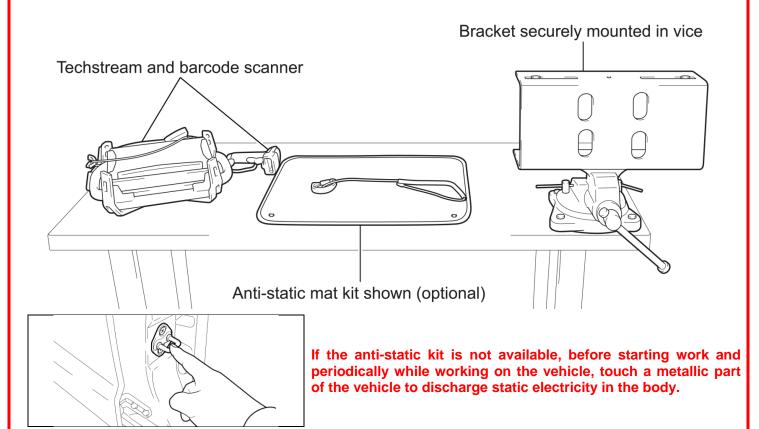
The bracket assembly that was provided at the launch of SSC D0F is a critical added-safety feature that *MUST* be used when replacing the inflator module. Confirm the bracket assembly is installed securely in the vise and confirm the work area being used is appropriate. The anti-static mat set that is an essential SST may be available at your dealership and is optional to use during inflator replacement. If the anti-static kit is not available, before starting work and periodically while working on the vehicle, touch a metallic part of the vehicle to discharge static electricity in the body.

Confirm there are no loose objects or people exposed to the back side of the bracket for safety in the unlikely event of airbag deployment due to improper work procedures (Remember that the inflator *IS NOT* being replaced due to an inadvertent deployment concern).

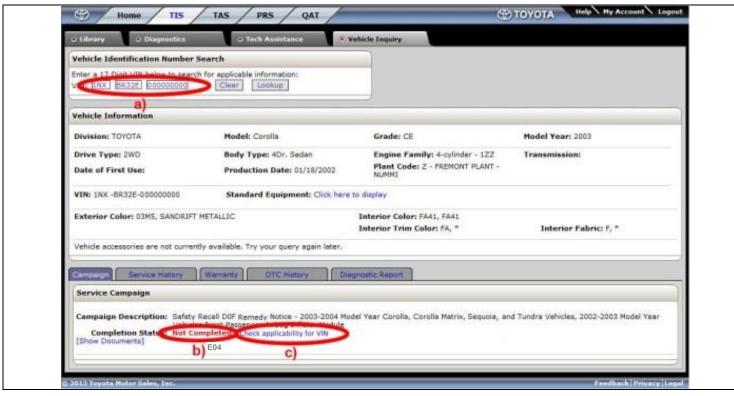
- The AIRBAG ASSEMBLY, ORIGINAL INFLATOR, and NEW INFLATOR serial numbers MUST be recorded using the barcode scanner (provided at the launch of SSC D0F).
- The barcode scanner application MUST be completed on every vehicle. These numbers MUST be included on every warranty claim that is submitted for inflator module replacement or the claim may be subject to debit.
- The technician performing the work MUST have valid TIS login credentials and an internet connection to perform the inspection and scanning process.
- a) Log in to TIS and input the VIN of the vehicle in the Vehicle Inquiry tab.
- b) Confirm the VIN is applicable and that the campaign has not been completed.
- c) Click on the link to launch the serial number recording application.

Note: The Serial Number Recording Application is the same as the DSF application, so the screens will still indicate campaign DSF.

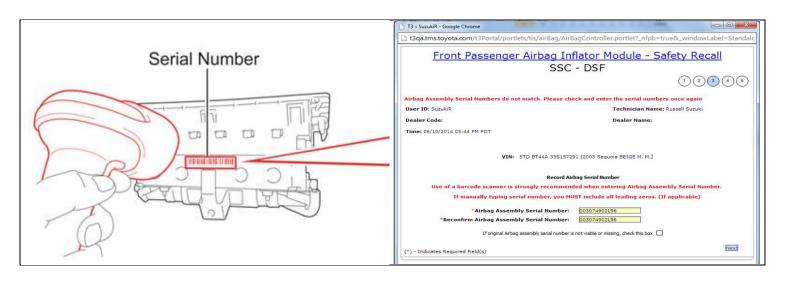
Airbag Serial Number Label Example

- The airbag serial number is *ALWAYS* the 12 *DIGITS* located between the asterisks.
- The 3 digits before the asterisk ARE NOT part of the serial number, and SHOULD NOT be entered or an inaccurate response may be returned.

The AIRBAG ASSEMBLY serial number and the INFLATOR serial number are DIFFERENT. The AIRBAG ASSEMBLY serial number MUST be recorded prior to replacement.

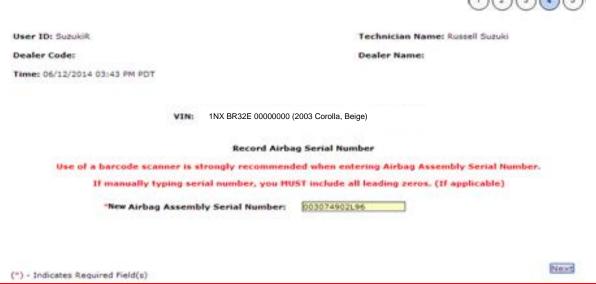
b) After the Region approves the Airbag Assembly replacement and the new part is received, record the NEW airbag serial number in the Serial Number Recording Application.

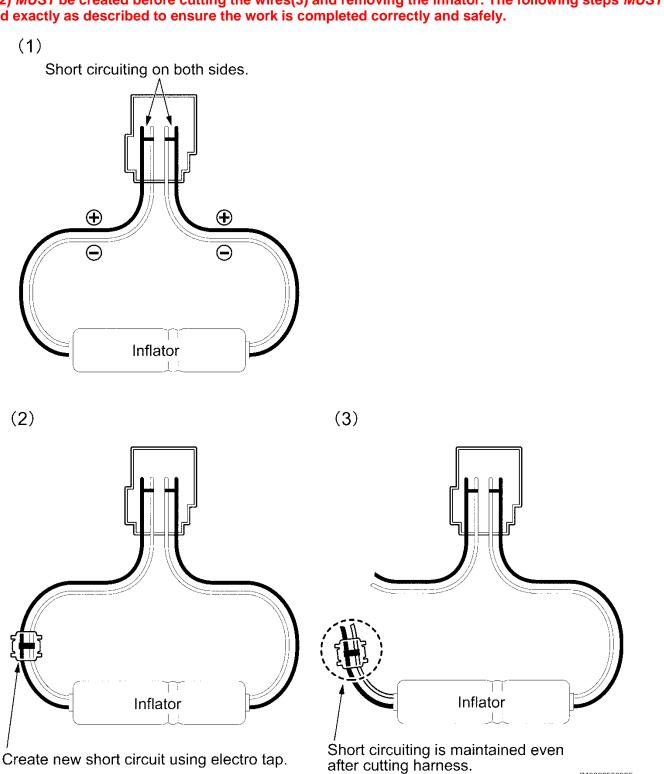
R1302250036E

The connector of the inflator module contains a short circuiting mechanism to eliminate voltage variances when the connector(1) is disconnected. To allow for the replacement of the inflator module, a new short circuit(2) MUST be created before cutting the wires(3) and removing the inflator. The following steps MUST be followed exactly as described to ensure the work is completed correctly and safely.

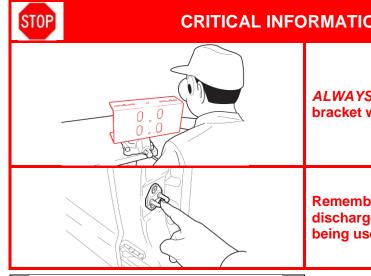
- a) Position the two mounting studs on the airbag assembly into the holes on the bracket support bars.
- b) Install the airbag to the support bars with the nuts supplied in the bracket kit.
- c) Position the airbag so that all four stopper plate nuts can be removed through the access holes.
- d) Tighten the nuts holding the support bars to the mounting bracket.
- e) Confirm the following:
 - Mounting bracket is secure in the vise.
 - Airbag is secure in the support bars.
 - The center mounting bracket on the airbag assembly is facing upward.
 - Support bars are secure on the mounting bracket using 1 bolt/nut at the top of each support bar and 2 nuts/bolts at the bottom of each support bar.

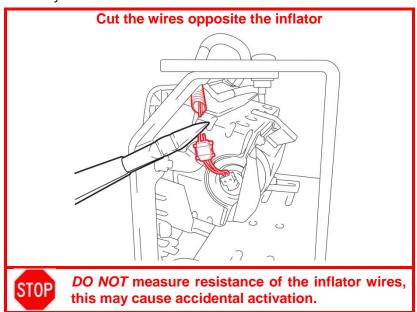
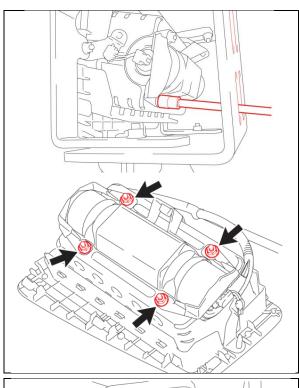
a) Cut the 2 wires at the side of the electro tap that is farthest away from the inflator.

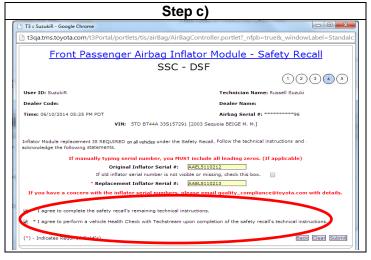
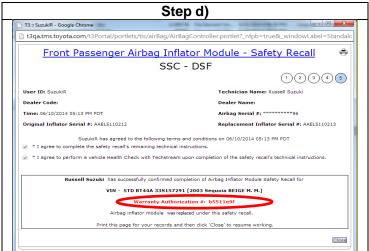
- a) Scan the OLD inflator serial number and mark the old inflator so that it will not be reused.
- b) Scan the **NEW** inflator serial number.

- c) Confirm agreement by checking the two boxes.
- d) Record the Warranty Authorization # to be included in the warranty claim.
- e) Place the old inflator in the parts box and take it immediately to the parts department.

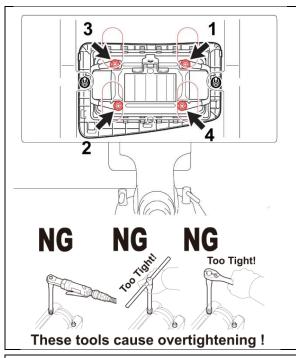
- a) Place the **NEW** stopper plate on the airbag assembly on the side where the harness is already connected.
- b) Confirm the end of the inflator sits flat against the stopper plate. If they do not align the inflator is installed backward.
- c) Install NEW stopper plate nuts by hand. They will be torqued on a later step.

- Confirm the stopper plate to inflator fitment is correct.
- DO NOT pinch the harness between the inflator and the stopper plate.

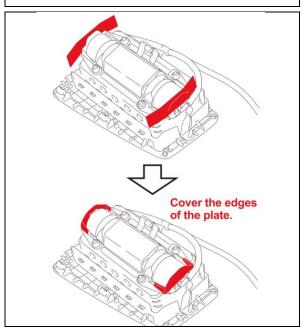
a) Attach the felt tape to the edges of the stopper and position determining plate.
